BOMB CRATER REPAIR TECHNIQUES FOR PERMANENT AIRFIELDS

TECHNICAL REPORT GL-81-12

Report 3
SERIES 4 TESTS

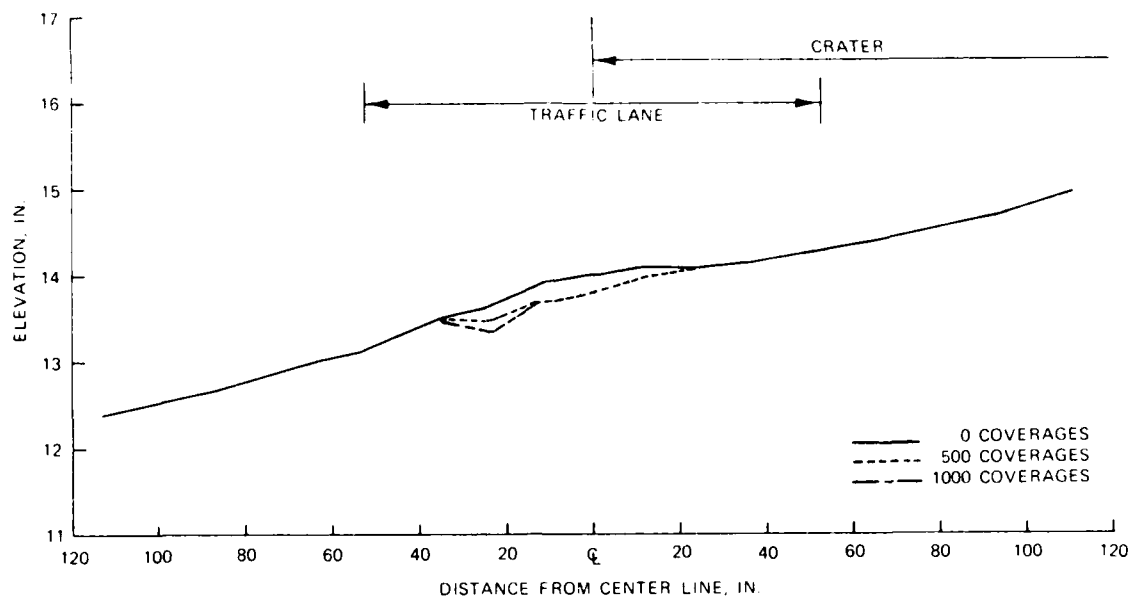
Figure 6. Cross-section data for crater 1, lane 1

After 340 passes or 100 coverages, traffic was stopped in lane 1 in order to allow for the continuation of traffic in lane 2. However, C-141 traffic was resumed in lane 1 308 hr after placement of the crater repair. After 2754 passes or 810 coverages, a longitudinal crack became visible on the edge of the traffic lane and there was minor spalling in the southeast corner of the crater repair. Photo 22 shows surface conditions after 3400 passes or 1000 coverages with the longitudinal crack outlined but not the shrinkage cracks as in Photo 21. The longitudinal crack appeared to be the only structural damage with very minor spalling along the edge of the crack. Figure 6 shows typical cross-section data for this lane.

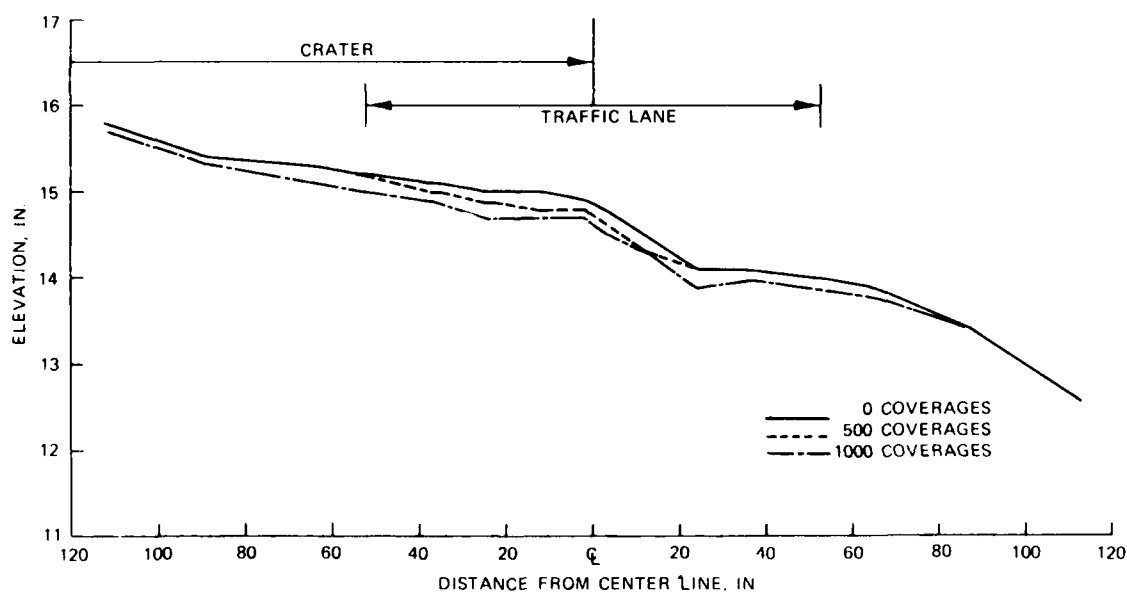
Figure 7. Cross-section data for crater 1, lane 2

24. Photo 23 is a general view of the traffic lane before traffic. C-141 traffic was started 18 hr after the crater repair was finished. After 68 passes or 20 coverages, there were 3 shrinkage cracks in the traffic lane. After 340 passes or 100 coverages, there had been an increase in the shrinkage cracks and there was one longitudinal crack located outside the traffic lane (Photo 24). After 2788 passes or 820 coverages, there were two corner breaks plus the longitudinal crack. One thousand coverages or 3400 passes were applied to the traffic lane within 290 hr (12 days) after placement, and at this time there was one longitudinal crack and three corner breaks, with very minor spalling (Photo 25). Figure 7 shows typical cross-section data for the traffic lane.

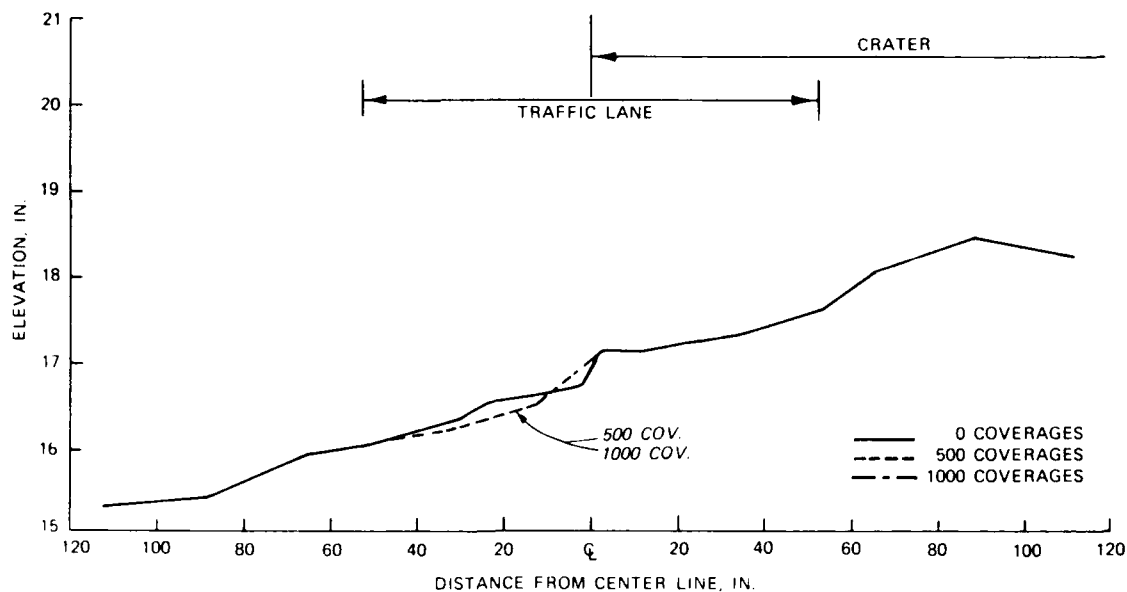
Figure 8. Cross-section data for crater 2, lane 1

shrinkage cracks that occurred during this traffic. There was no increase in shrinkage cracks when traffic was resumed and continued to 3400 passes or 1000 coverages. Only very minor spalling at one location along the edge of the crater was noted (Photo 30). Figure 8 shows typical cross-section data for the traffic lane.

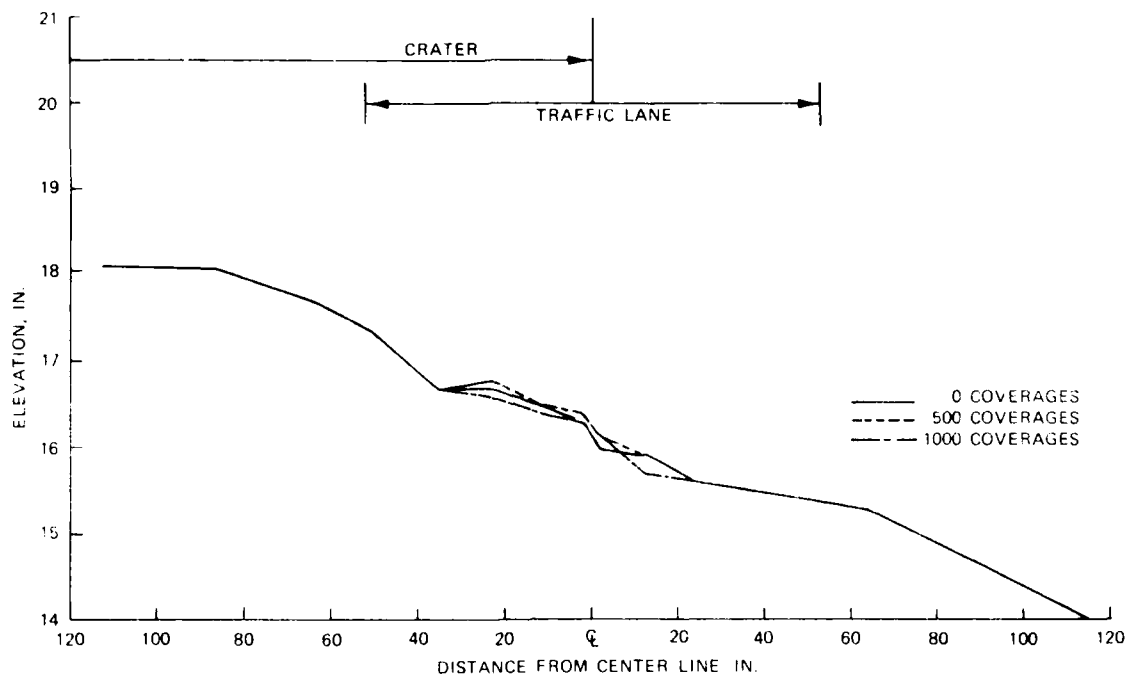
Figure 9. Cross-section data for crater 2, lane 2

27. Photo 31 is a general view of the traffic lane before C-141 traffic. As in crater 1, lane 2, traffic was applied at different time intervals. Shrinkage cracks developed with time and traffic as in the previous traffic lanes. After 204 passes or 60 coverages, the lane contained one corner break in the northeast corner. Photo 32 shows the shrinkage cracks and corner break after 340 passes or 100 coverages. After 2788 passes or 820 coverages, there were two corner breaks and very minor spalling along the edge of the crater. There were no additional defects when traffic was stopped at 3400 passes or 1000 coverages (Photo 33). Figure 9 shows cross-section data for this lane.

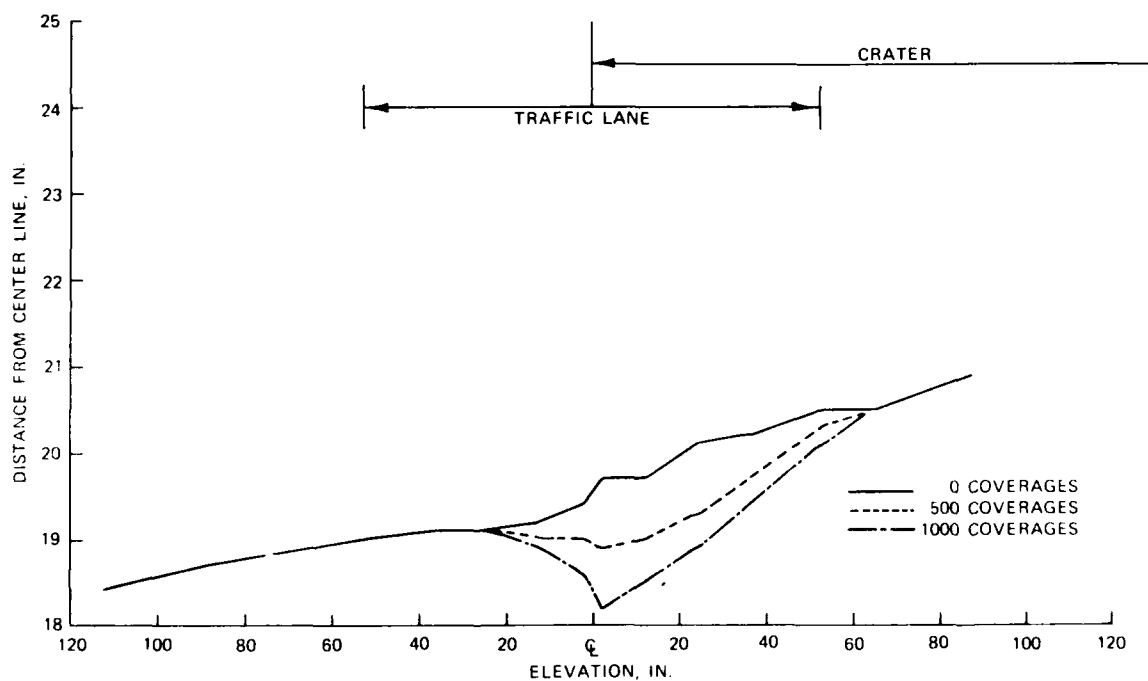
Figure 11. Cross-section data for west end of crater 3, lane 1

gravel in the rutted area. This material became unstable and shifted under the wheel. Photo 35 shows the surface condition after 550 passes or 72 coverages of the F-4. Figure 10 shows typical cross-section data of the rutted area. The loose material was removed from the rutted area and replaced with a well-graded crushed limestone and rolled 4 passes with the vibratory roller at 36-kip dynamic force. In repairing the rutted area it was found that the loose material was confined to the top 5 in., which was the last lift placed in the section. The stabilized sandy gravel under the rutted area was in excellent condition; this was the second lift placed in the repair. The rutted area was repaired to see if it was possible to patch a small area such as this with crushed limestone and continue traffic on craters 2 and 4. Photo 36 shows the traffic lane after 340 passes or 100 coverages of C-141 traffic, with no apparent damage. Note that the limestone repair is in the background. At 952 passes or 280 coverages a 1-in. rut had developed in the stabilized material at the edge of the patched area. This rut did not increase in depth as traffic continued. However, a 1-in. rut developed in the southwest corner and along the south edge of the crater repair after 1700 passes or 500 coverages. This rut increased in depth to 2 in. with the continuation of traffic to 3400 passes or 1000 coverages (Photo 37). Figure 11 shows cross-section data for the west end of the traffic lane.

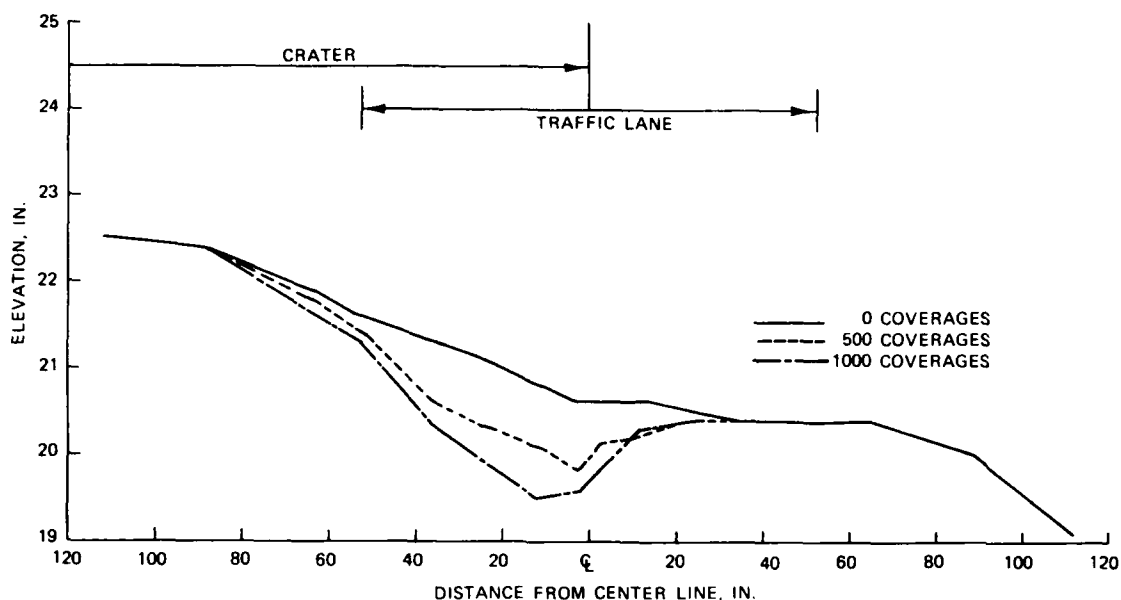
Figure 12. Cross-section data for crater 3, lane 2

until after 2040 passes or 600 coverages, at which time the rut depth was 2.5 in. The deteriorated area increased in length and rut depth between 2040 passes or 600 coverages and 3400 passes or 1000 coverages.

The length was approximately 15 ft and the rut depth was 3.5 in. Raveling of the surface gravel was starting in the northwest corner of the crater at this time (Photo 40). Figure 12 shows typical cross-section data for this traffic lane.

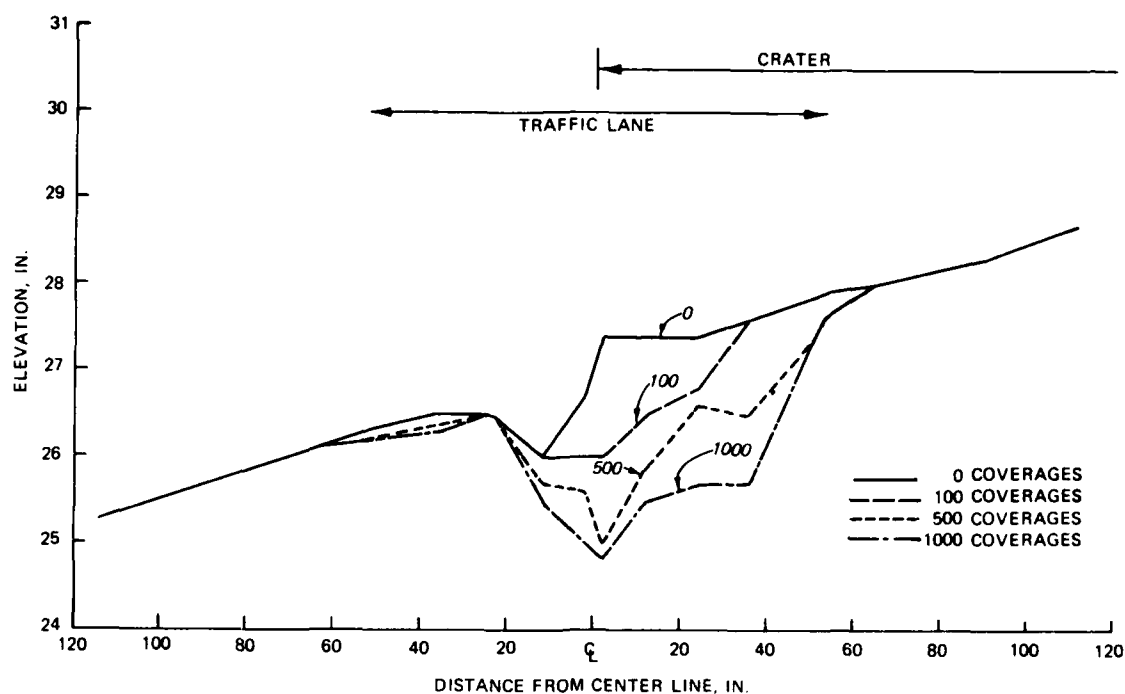
Figure 15. Cross-section data for the east end of crater 5, lane 1

the bleeding asphalt and prevent further removal of the DBST. After 1156 passes or 340 coverages there was minor rutting in the DBST and the bond between the DBST and crushed limestone was broken at the edge of the crater in the east half of the traffic lane. Settlement of the AC over PCC pavement was noted in the southeast corner of the traffic lane outside the crater repair. This area contained two breaks from a previous series of tests. After 1700 passes or 500 coverages the rutting continued in the DBST, with some displacement of the DBST outside of the crater repair (Photo 53). Along with consolidation of repair materials at the edge of the crater and additional settlement of the AC over PCC pavement, the maximum deformation was 3.5 in. at the east end of the traffic lane. Between 1700 passes or 500 coverages and 2074 passes or 610 coverages the DBST stopped the rutting and displacement and rebonded itself to the crushed limestone (Photo 54). However, because the displaced DBST bonded to the AC over PCC pavement, the crater repair materials consolidated, and the AC over PCC pavement settled additionally, a tire hazard developed at the east end of the traffic lane and traffic was stopped. Figure 15 shows cross-section data for the east end of the traffic lane, crater 5, lane 1.

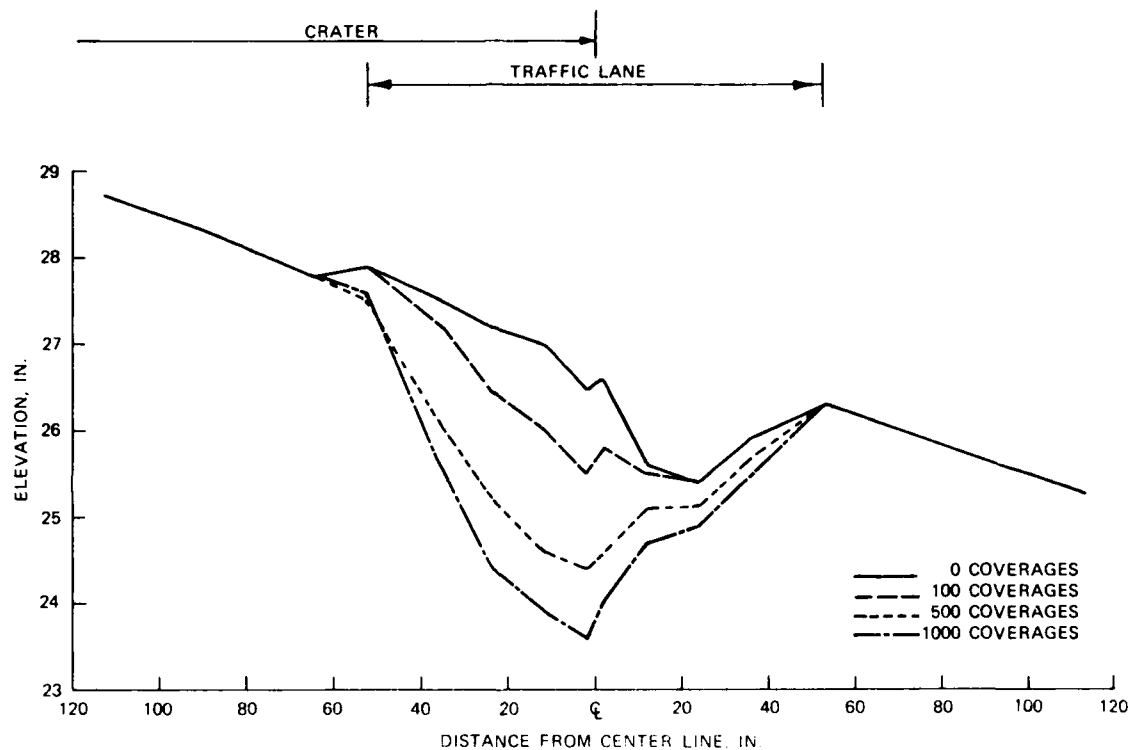
Figure 16. Cross-section data for crater 5, lane 1

impressions in the DBST. The average deformation was 2.0 in. and the maximum was 3.0 in. The consolidation of the repair materials and the settlement of the AC over PCC pavement continued and after 3400 passes or 1000 coverages the average deformation was 2.4 in. and the maximum was 3.25 in. (Photo 57). There also was minor bleeding of the asphalt in the DBST. Figure 16 shows cross-section data for crater 5, lane 2.

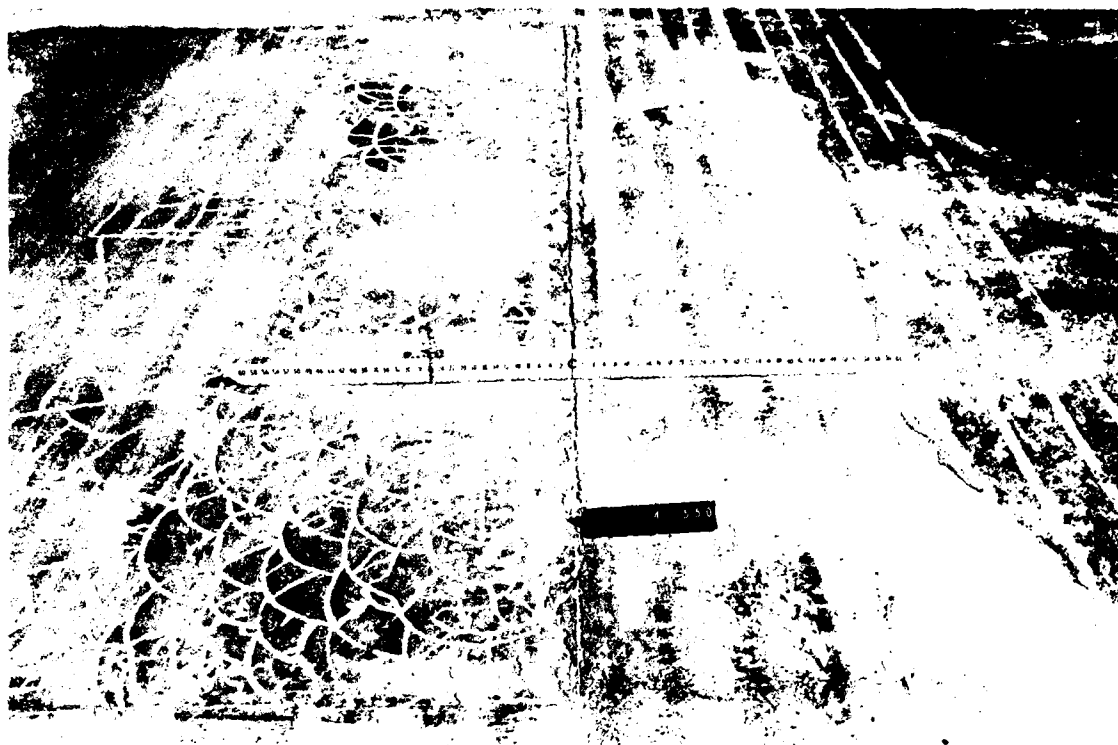
Photo 43. Crater 4, lane 1, after 72 coverages of F-4 traffic

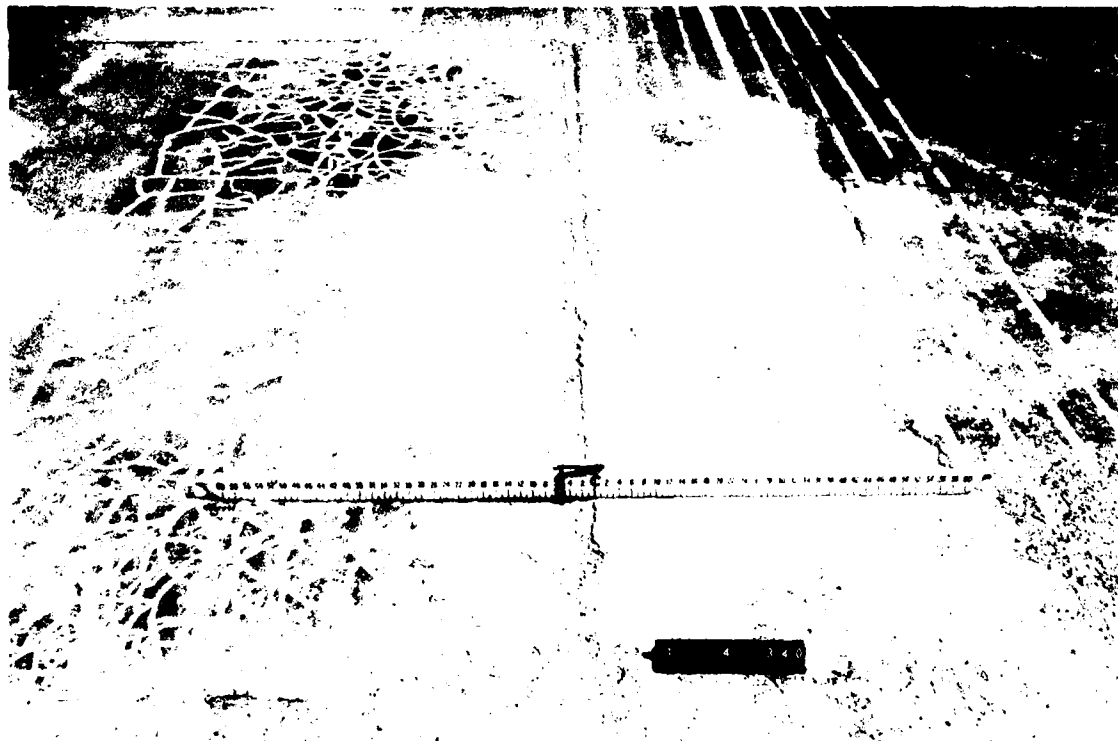
Photo 44. Crater 4, lane 1, after 100 coverages of C-141 traffic

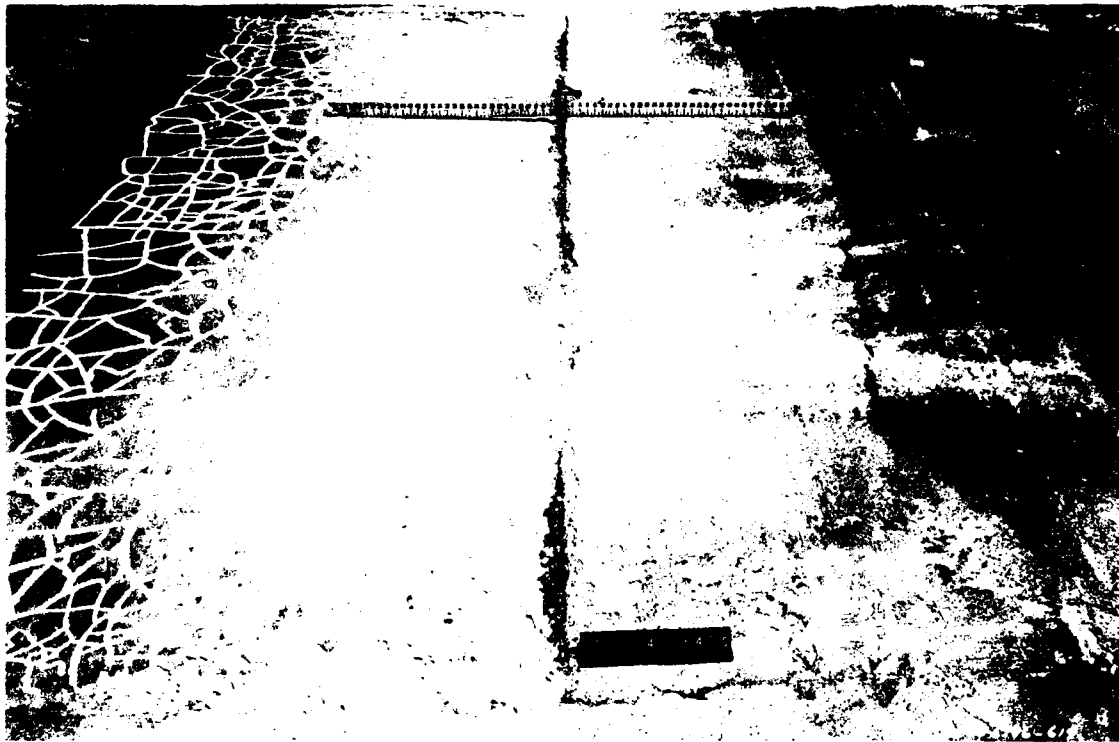
Photo 45. Crater 4, lane 1, after 1000 coverages of C-141 traffic
